**Report of
Geotechnical Exploration**

**Allegany College of Maryland (ACM)
Tennis Courts Renovation
Allegany County, Maryland**

Triad Project No. 03-20-0760

December 16, 2020

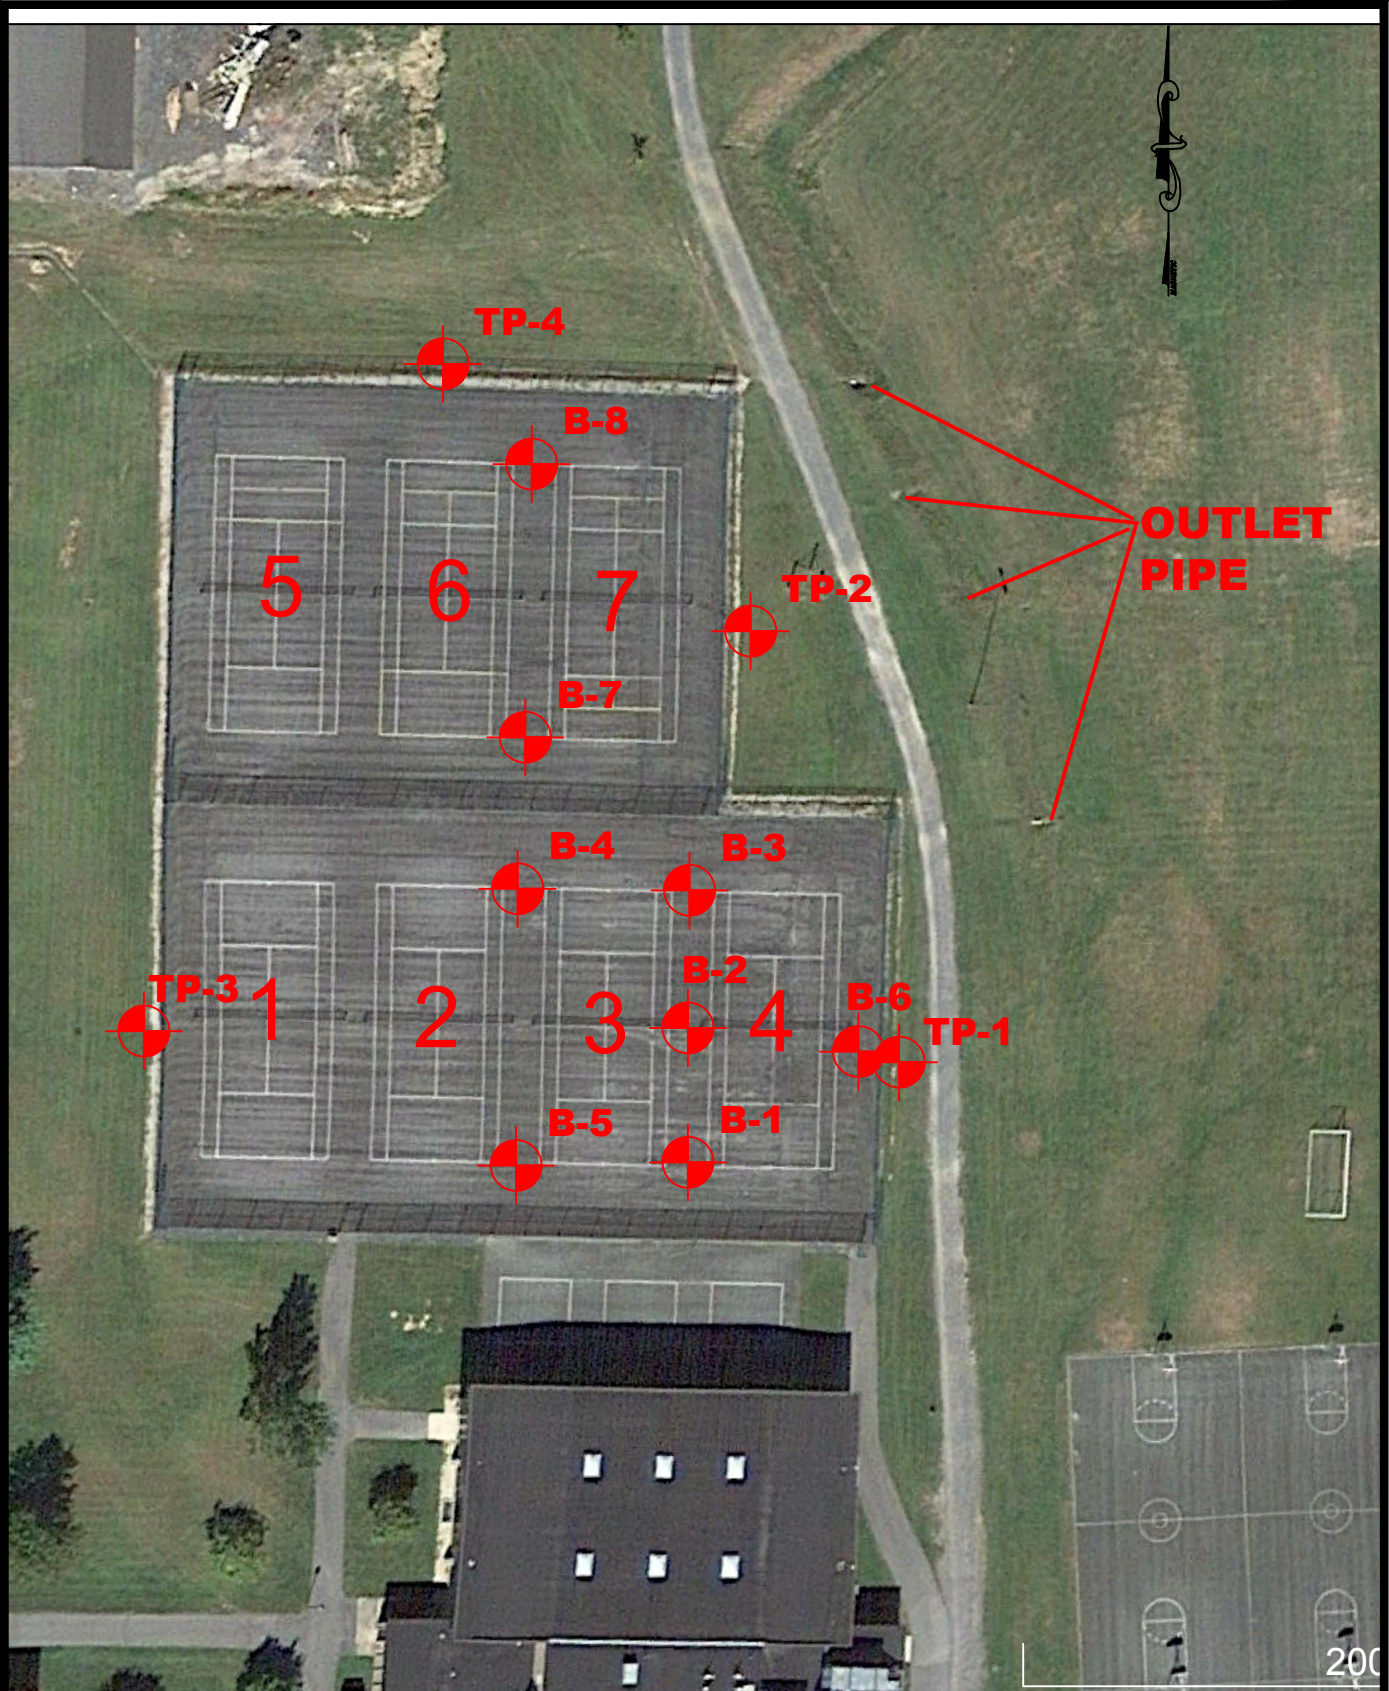
TRIAD ENGINEERING, INC. www.triadeng.com 1075-D SHERMAN AVENUE HAGERSTOWN, MD 21740
PREPARED BY: ARK	REVIEWED BY: SJG	<h2>ACM - TENNIS COURTS RENOVATION</h2>		
DATE: 11/30/2020	SCALE: N/A	PROJECT NO:03-20-0760	Figure: 2

The field exploration included coring the asphalt, performing Wildcat[®] Dynamic Cone Penetrometer (DCP) testing and hand augers at eight (8) test locations (Figure 2). Additionally, four (4) test pits were excavated around the outside edge of the tennis courts, and a camera was pushed into the four (4) outlet pipes. The test locations were selected by Triad, visually based on the existing site conditions. The ground surface elevations were not determined as part of the exploration. Refusal was encountered in all the test locations situated on the tennis courts. Considering that the exploration was limited to the use of hand equipment, the refusal depths should not be necessarily interpreted as bedrock.

The results of the hand augers and Wildcat[®] (DCP) testing indicate that the materials were generally in a medium stiff to very stiff condition. The testing performed indicated that the upper 4 to 8 inches of subgrade material was considered loose or medium stiff, based on the N' values derived from the DCP testing, but we did not detect any void space beneath the asphalt. However, our testing was limited to the depths explored. Monitoring and testing records during construction were not provided for our review. Therefore, we cannot comment on the condition of subsurface materials below the depths explored. The asphalt cores indicated that the majority of the asphalt is in a poor condition, and in several of the test locations, the asphalt condition was worse with increasing depth. The asphalt was underlain by tan silty clay. The soils encountered in all of the hand auger locations were saturated. Groundwater readings were taken upon completion of the coring, and 24 hour readings were also measured. It should be noted that our exploration was completed within a day after a significant rain event.

Test Location	Groundwater After Coring (Depth below ground surface)	24-Hour Groundwater Reading (Depth below ground surface)
B-1	2 in.	6 in.
B-2	2 in.	6 in.
B-3	DRY	DRY
B-4	7 in.	7 in.
B-5	5 in.	7 in.
B-6	5 in.	7 in.
B-7	7 in.	7 in.
B-8	7 in.	7 in.

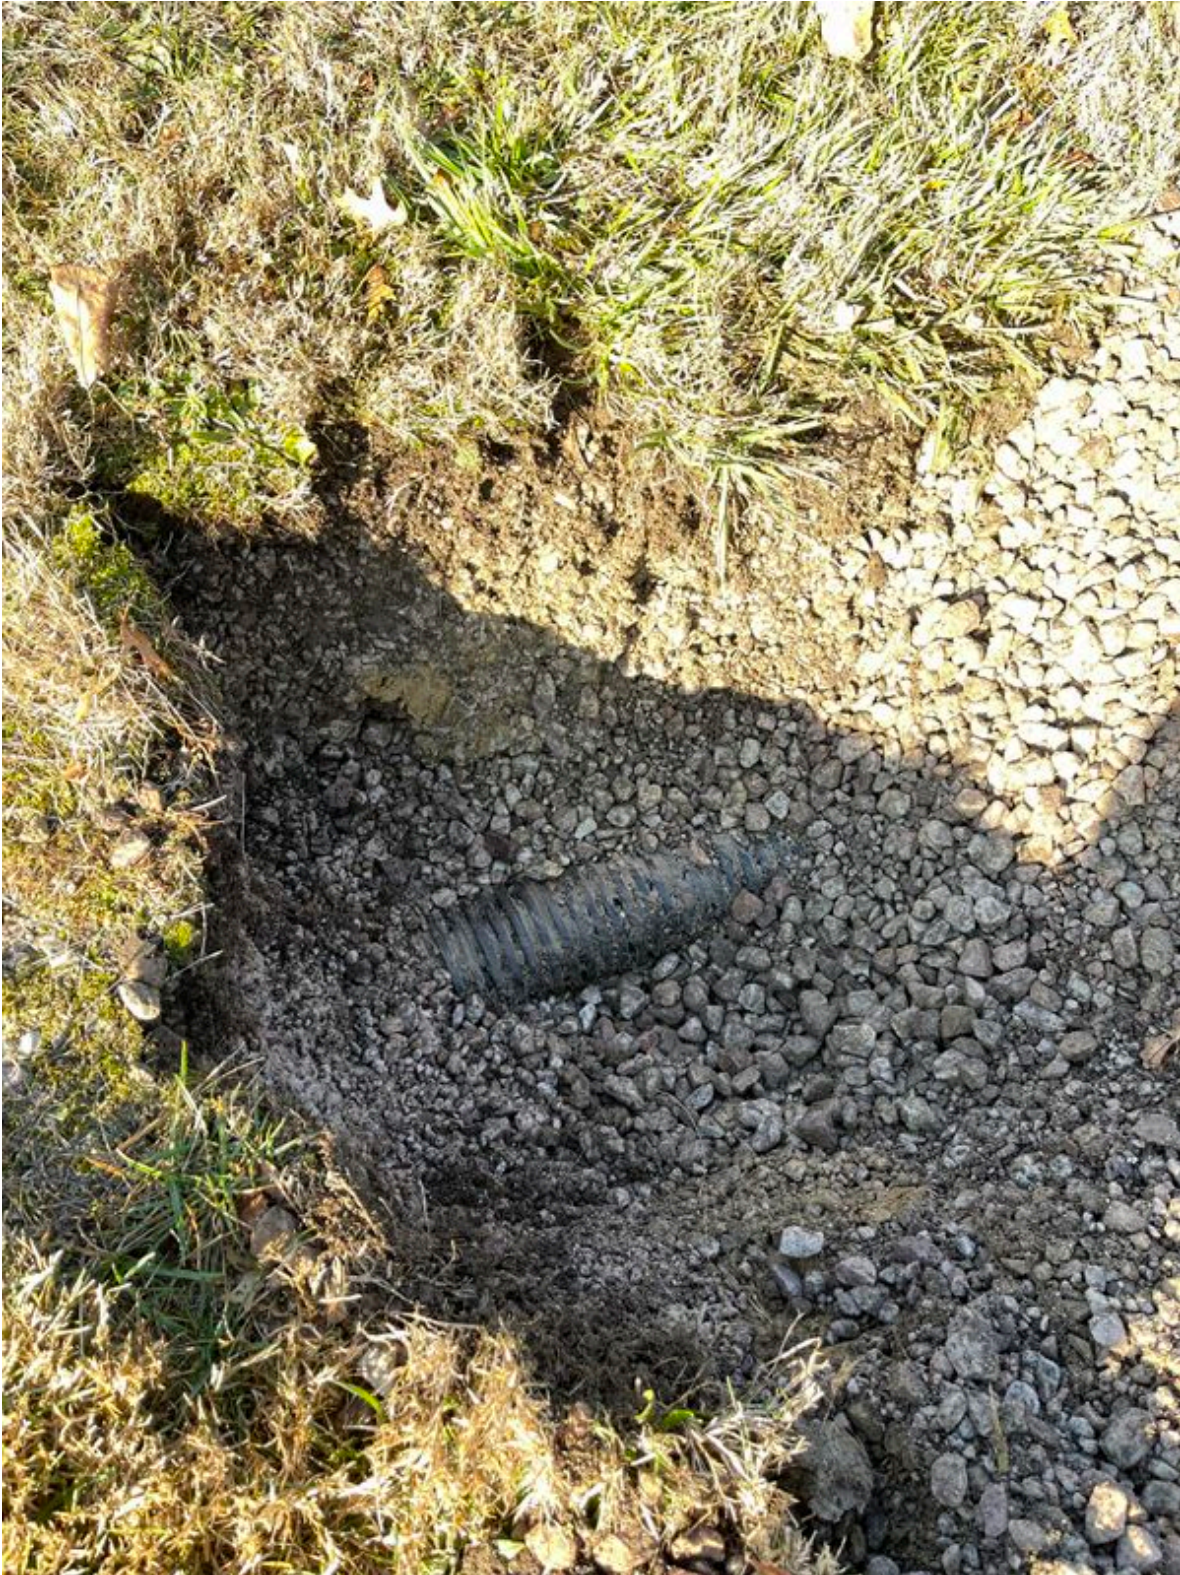
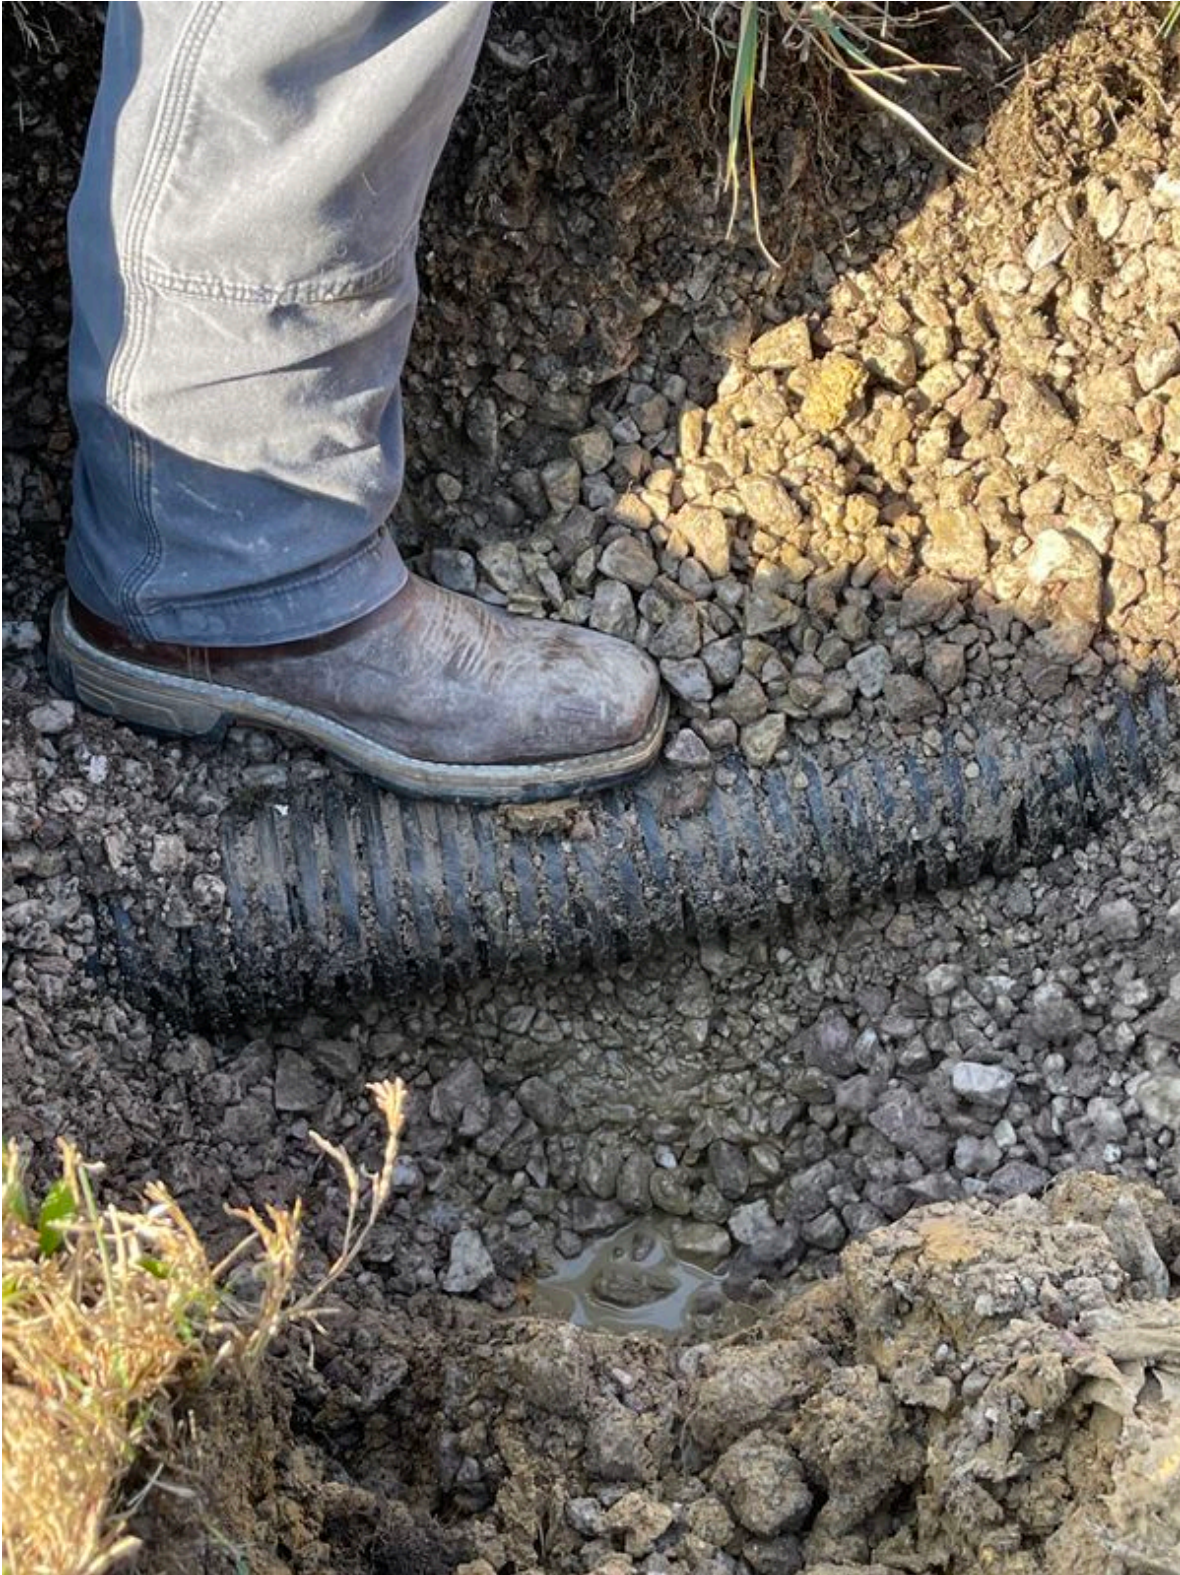
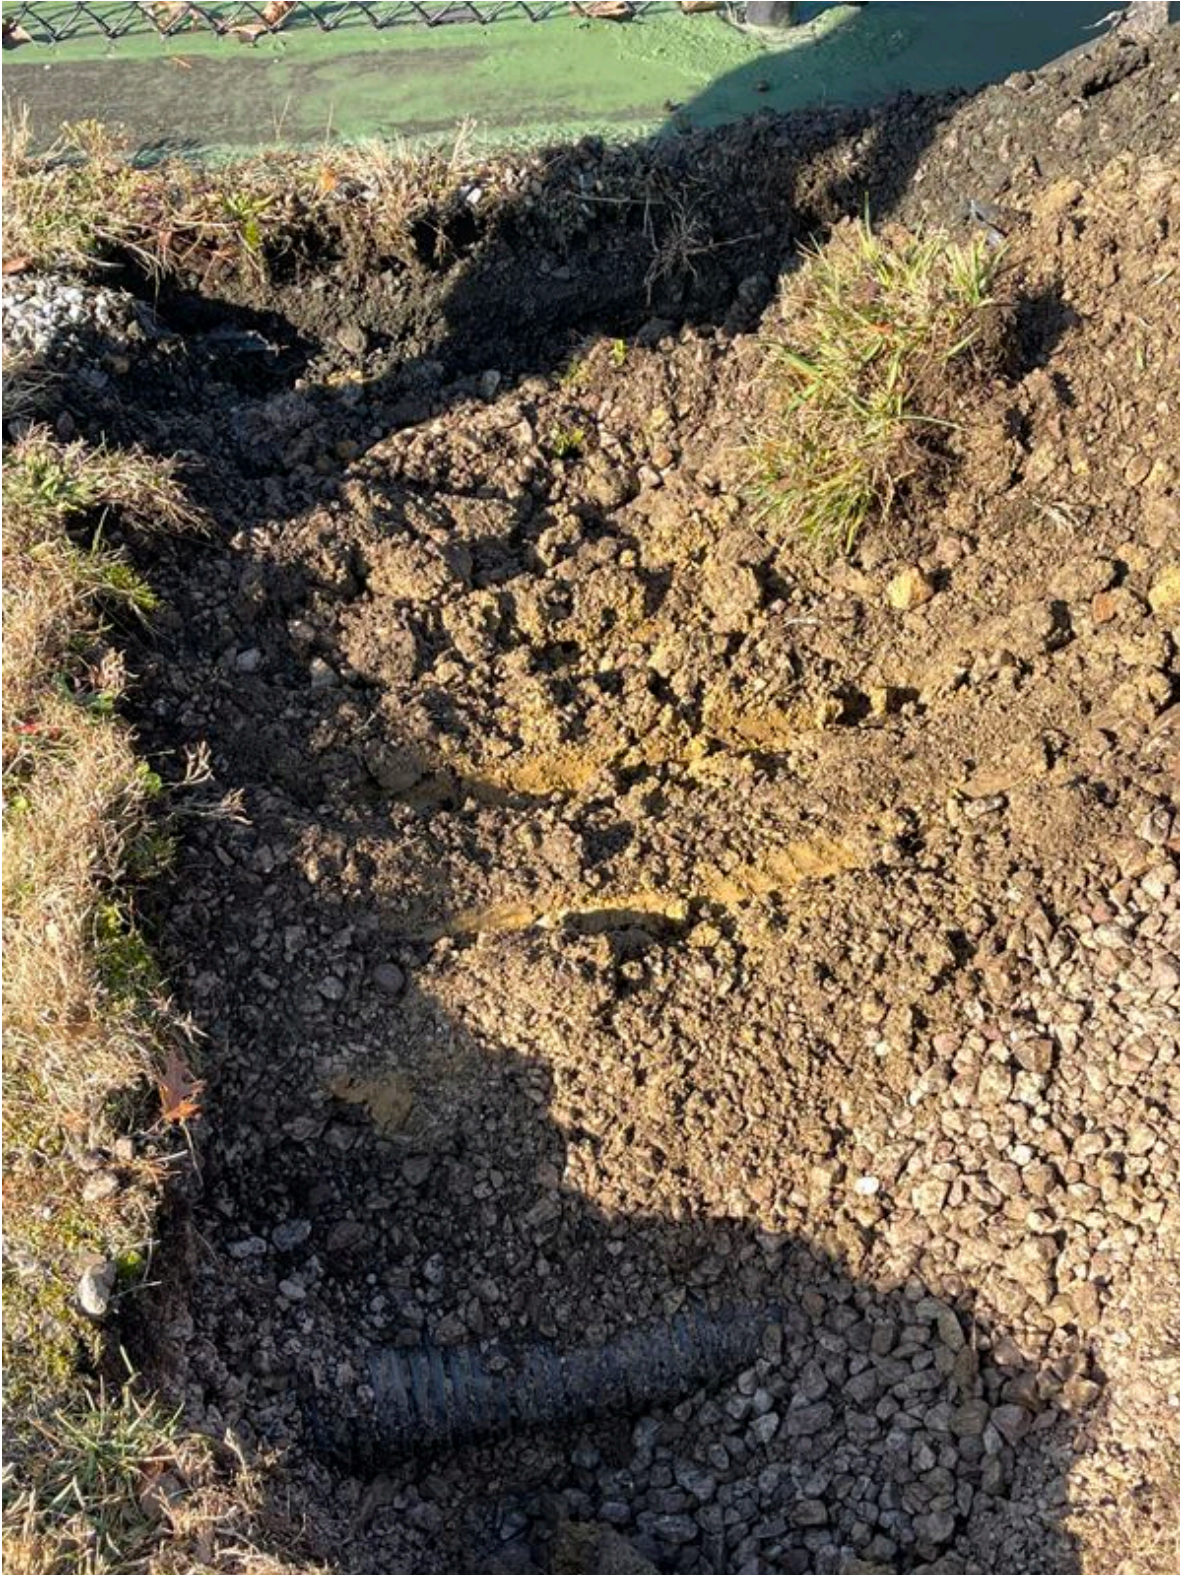
Test pits were excavated along the outside edge of the tennis courts to observe the subsurface conditions. In test pits TP-1, TP-2 and TP-4, a pipe was encountered at 16 inches, 12 inches and 3 feet below the existing ground surface, respectively. Water was perched on the soil below the pipe and stone in test pits TP-1 and TP-4. The pipe in test pits TP-1 and TP-2 was 4 inch corrugated plastic pipe. Generally, the grooves of the corrugated pipe were plugged with soil/aggregate fines. The pipe encountered in test pit TP-4 consisted of a 4 inch smooth pipe with holes drilled on the underside of the pipe. Each of the pipes was surrounded with gravel. While imaging the inside of the northern most pipe, ponded water was encountered in portions of the pipe. There were no punctures or clogs encountered during imaging of any of the pipes. The imaging of the pipes was limited to 140 feet from the outlets.

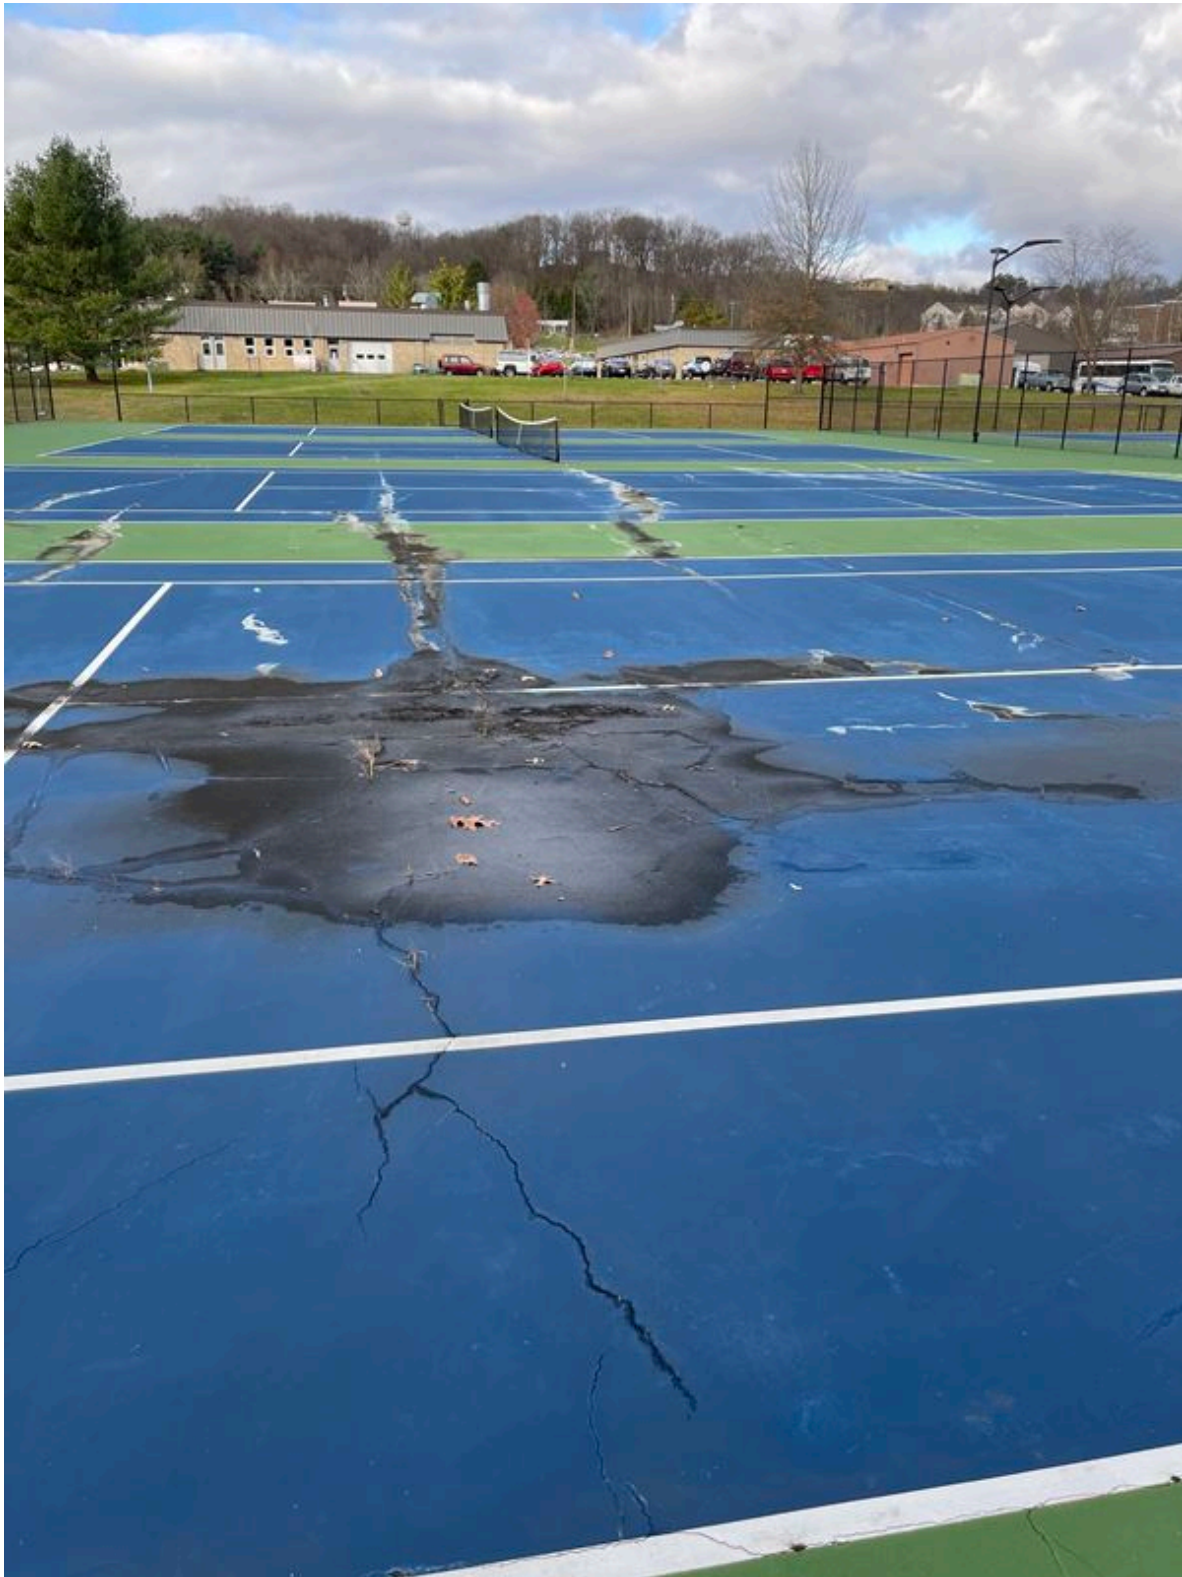
Courts 3 and 4

The project involves seven (7) existing tennis courts located at Allegany College of Maryland in Cumberland, Maryland (Figure 1). The tennis courts contain many areas of notable cracking, and water is seeping up through the cracks. It was requested that we perform testing to determine the most probable cause of the cracking and seeping water and provide recommendations for corrective measures. At the time of our exploration, cracking was observed on all the courts. The cracking was most severe on courts 3, 4 and 7 (eastern most courts). Drainage swales are located below the parking lot on the western side of the tennis courts and below the track to the east of the tennis courts. The perimeter drains for the tennis courts daylight to the swale to the east of the tennis courts. The site grading around the tennis courts generally slopes from west to east. Additionally, the grade to the north of the courts is sloped toward the courts.
